**Cambria Community Services District
Water Reclamation Facility
Adaptive Management Plan
Annual Report
2022**

January 14, 2023

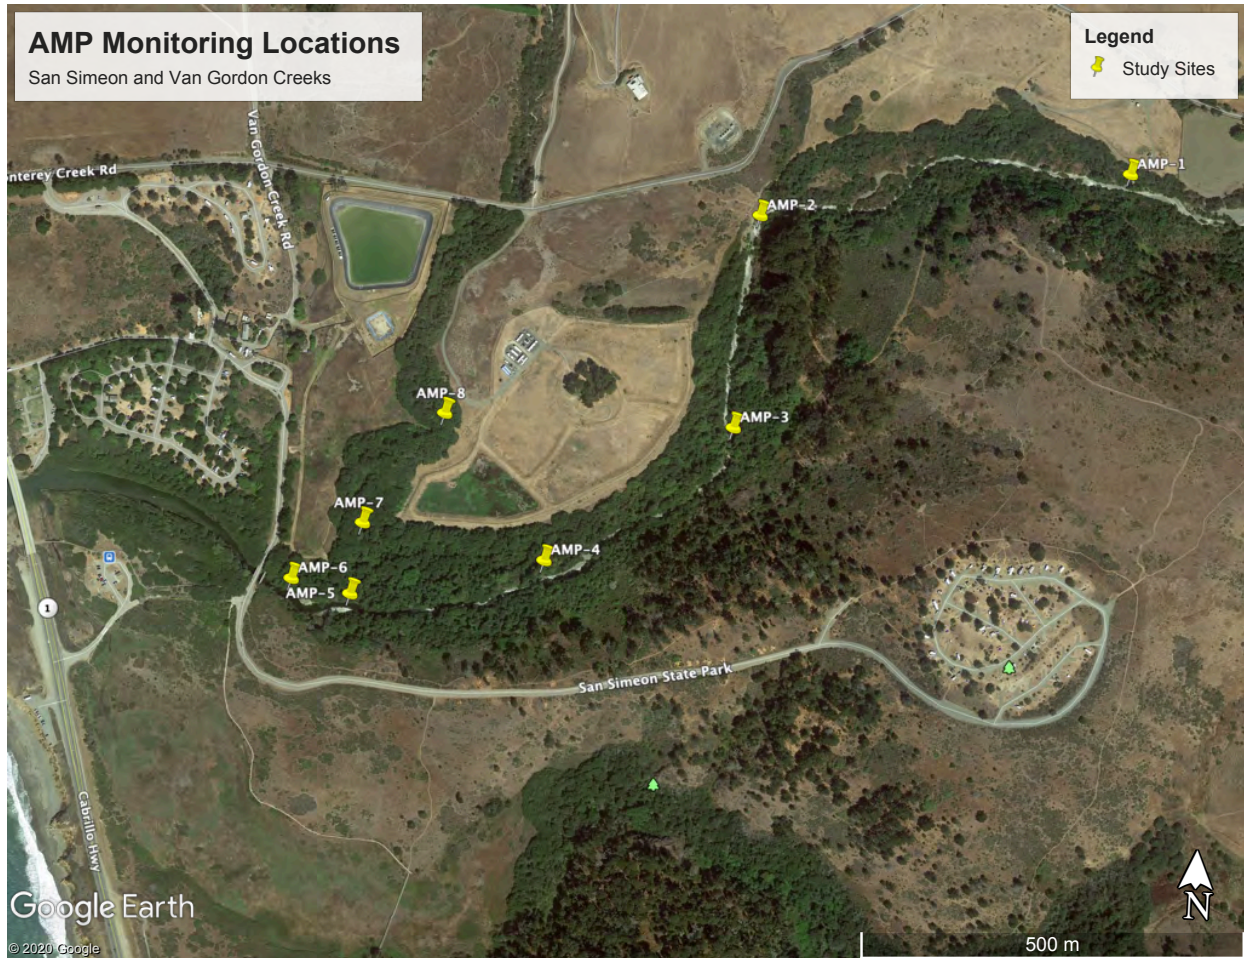
Figure 2. AMP monitoring survey site locations.

As identified in the AMP, survey sites are located on San Simeon Creek and Van Gordon Creek within CCSD property. The survey sites are described below by survey site number, creek, access description, site description, and GPS coordinates.

Per methods described in the AMP, four biological surveys were conducted at seven survey sites to collect habitat, hydrological, water quality, and species information (Figure 2).

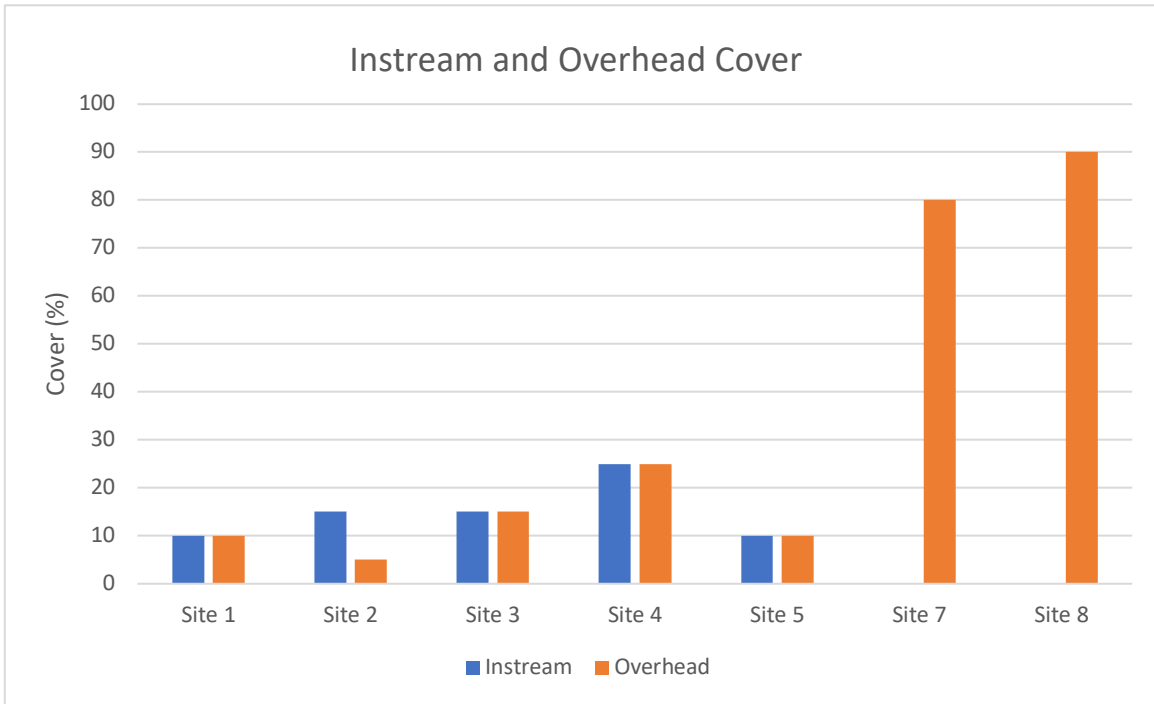
Figure 8. Instream and overhead cover

The graphs below present the survey data for instream and overhead cover, riparian width, and riparian moisture (Figures 8 through 11). Instream and overhead cover and riparian width did not change during the year. Riparian moisture changed often – sometimes, the change was due to weather, but the readings would also vary if measurements were taken within inches of each other; the usefulness of this data is in question. Aerial photos of riparian vegetation were analyzed with no observed significant changes.

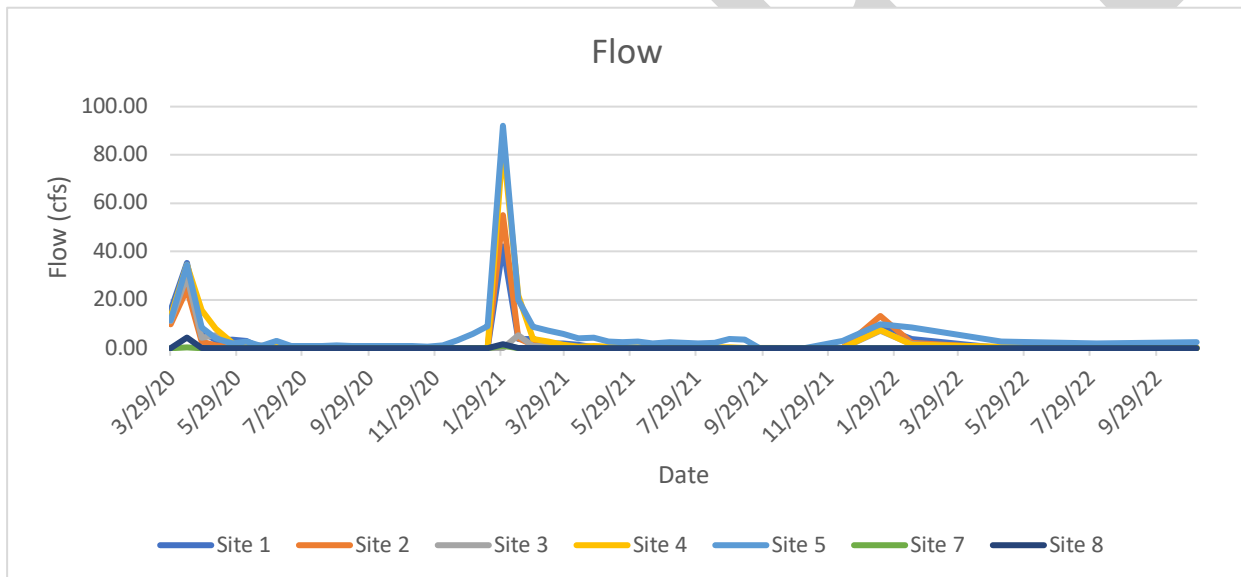
Figure 15. Flow.

Wetted width, maximum depth, average depth, and flow were measured year-round at sites 4 and 5 but only during January and February for the other sites when they had water (Figures 12 through 15).
