**Cambria Sustainable Water Facility
Adaptive Management Plan
Annual Report
2020**

February 15, 2021

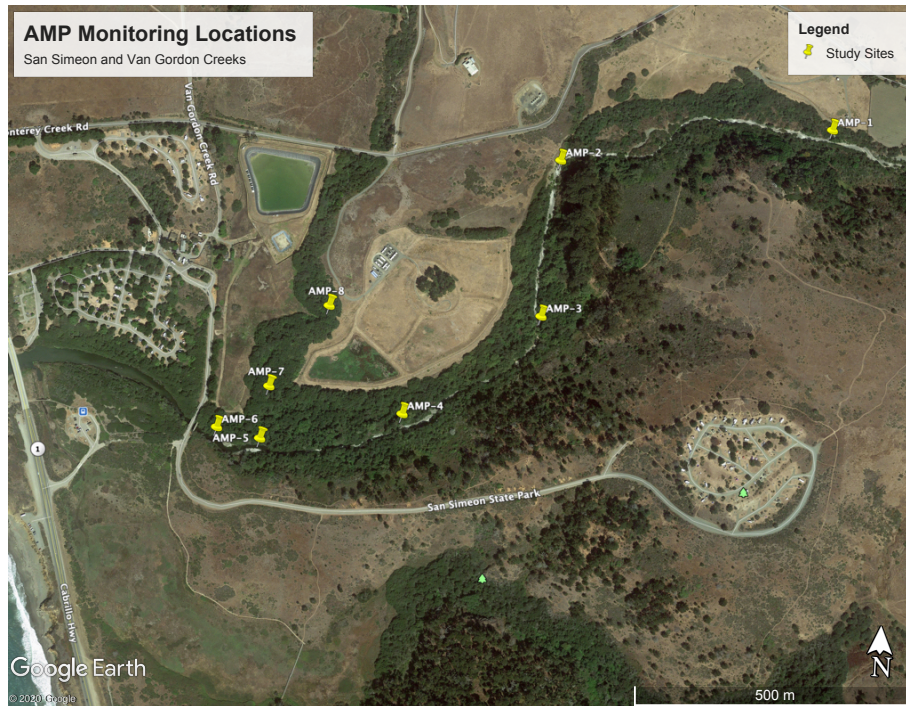
Per methods described in the AMP, biological surveys were conducted twice a month at 7 survey sites to collect habitat, vegetation, hydrological, water quality and species information. Survey sites and data collection methods are described below. See survey location map, below.

As identified in the AMP, survey sites are located on CCSD property on San Simeon Creek and Van Gordon Creek. The survey sites are described below by site number, creek, access description, site description, and GPS coordinates.

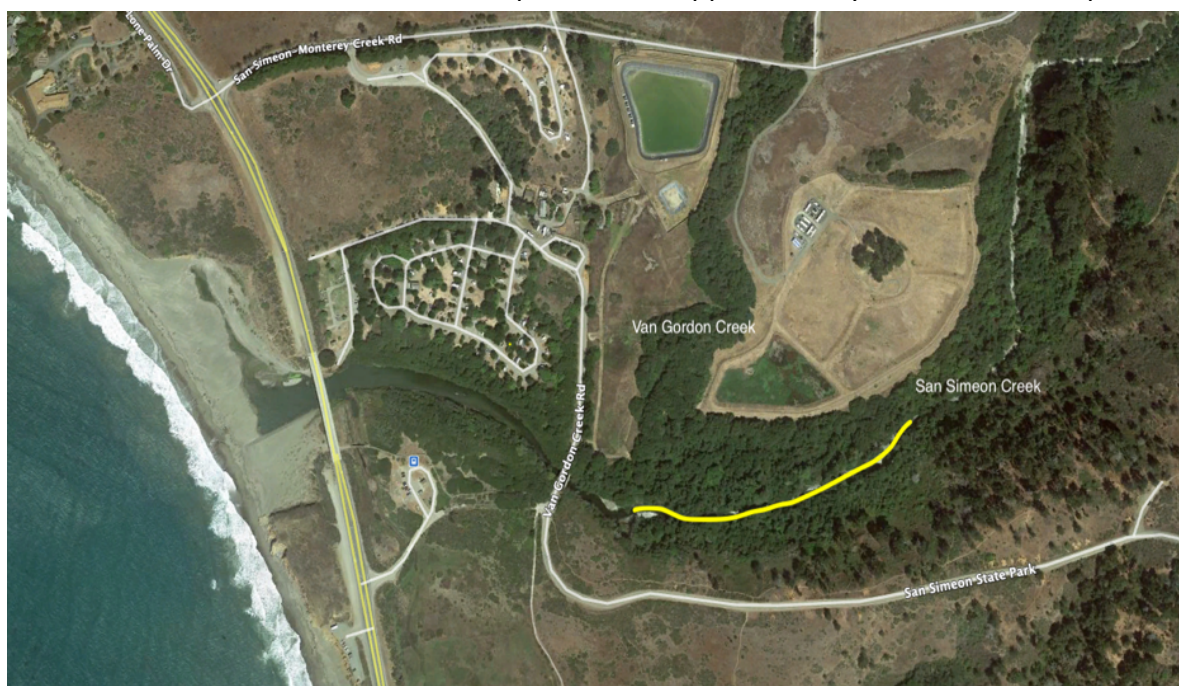
On March 18, 2020 and October 11, 2020 Cindy Cleveland and Paul Cleveland conducted daytime and nighttime California red-legged frog surveys following the protocol contained within the “Revised Guidance on Site Assessments and Field Surveys for the California Red-legged Frog” (USFWS 2005). The surveys were conducted within the study area that extended from the mouth of Van Gordon Creek upstream for approximately 900 feet, see map below.

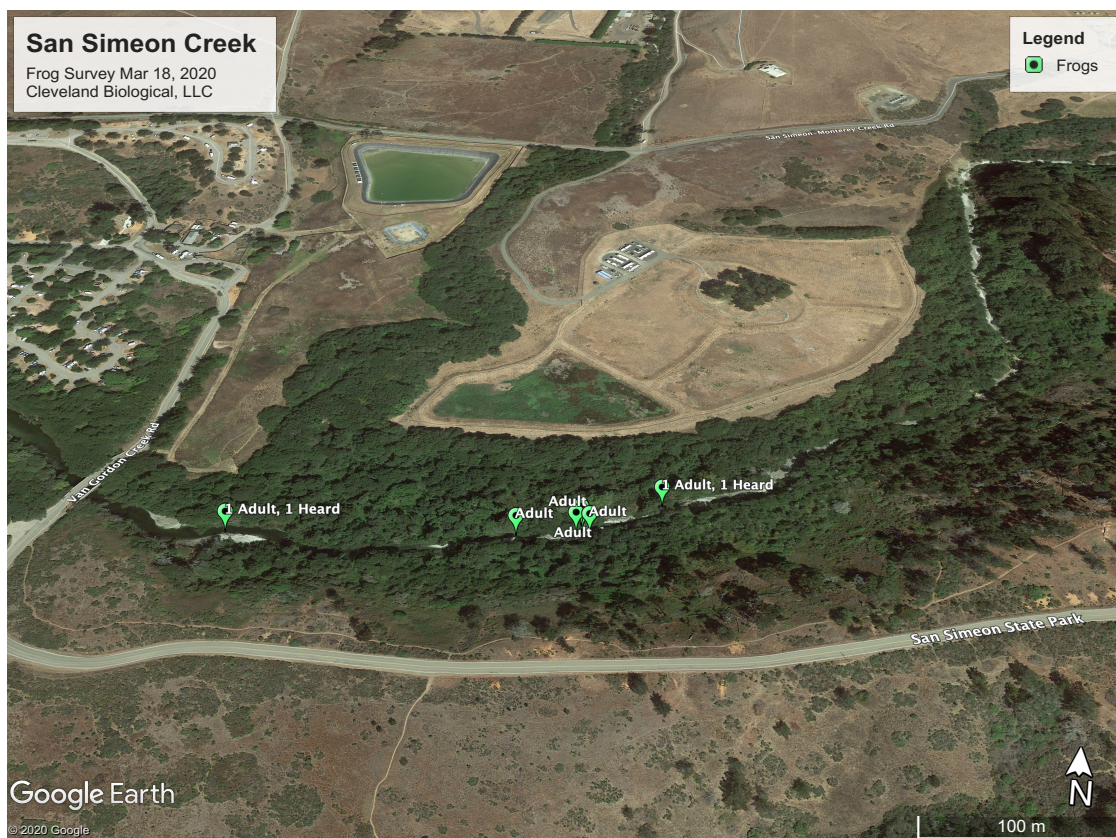
the daytime survey. The nighttime survey was completed at least one hour after sunset between the hours of 19:30 and 23:00. The moon phase was 32%, water temperature was 58 degrees Fahrenheit, humidity was 84%, and the wind was from the west and very light. The survey conditions were clear and calm. The stream flow was approximately 10 cfs with no algae and unembedded substrates. The deepest pool was approximately 5 feet with an average stream depth of 2 feet. Six adult California red-legged frogs were observed during the night survey and two other frog “plops” were heard but the species was not identified (see map below). No bullfrog “squawk” was heard when the unidentified frogs jumped, but based on professional experience, we find that bullfrogs often do not squawk when they jump into cover. One California red-legged frog advertisement call, with ending growls, was observed and recorded at night. The frog was sitting on a branch over a deep pool near the confluence of Van Gordon and San Simeon Creeks.

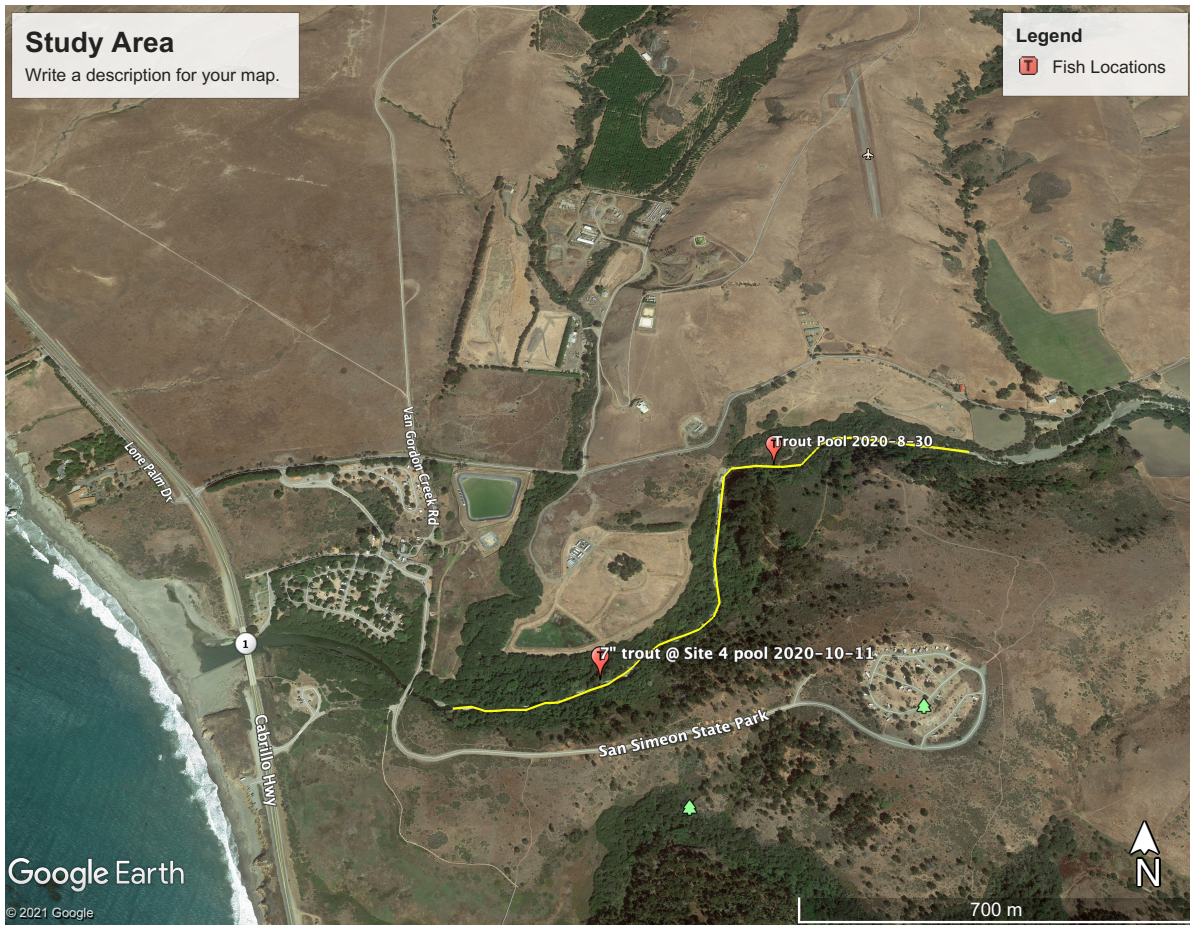
The October 11, 2020 survey was from 0:900 to 13:00. The high tide of 3.98 feet was at 07:51; the sandbar was not breached. The air temperature was 68 degrees Fahrenheit at the beginning of survey and was 80 degrees Fahrenheit at the end of the survey. The skies were clear for the entire survey. The water temperature was 63.5 degrees Fahrenheit at the Van Gordon and San Simeon Creek confluence and 60.9 degrees Fahrenheit where the streamflow ended near the middle of the survey area. The surveyed habitats were a mix of pools, runs, and riffles with mostly cobble and gravel substrates. The substrate embeddedness was on average 50%, there was no surface algae at any survey site and almost 100% subsurface algae over the entire survey area. The instream cover on average was 15% and overhead cover on average was 15%. The maximum depth was 1.1 feet, average depth was 0.5 feet, and flow was 0.1 ft/sec. Dissolved oxygen ranged from 2.52 to 4.35 ppm, total dissolved solids ranged from 461 to 700 mg/L, and salinity ranged from 0.35 to 0.54 ppt. Observed fish include many stickleback, one 8" steelhead trout, and one 4" prickly sculpin, see map below.

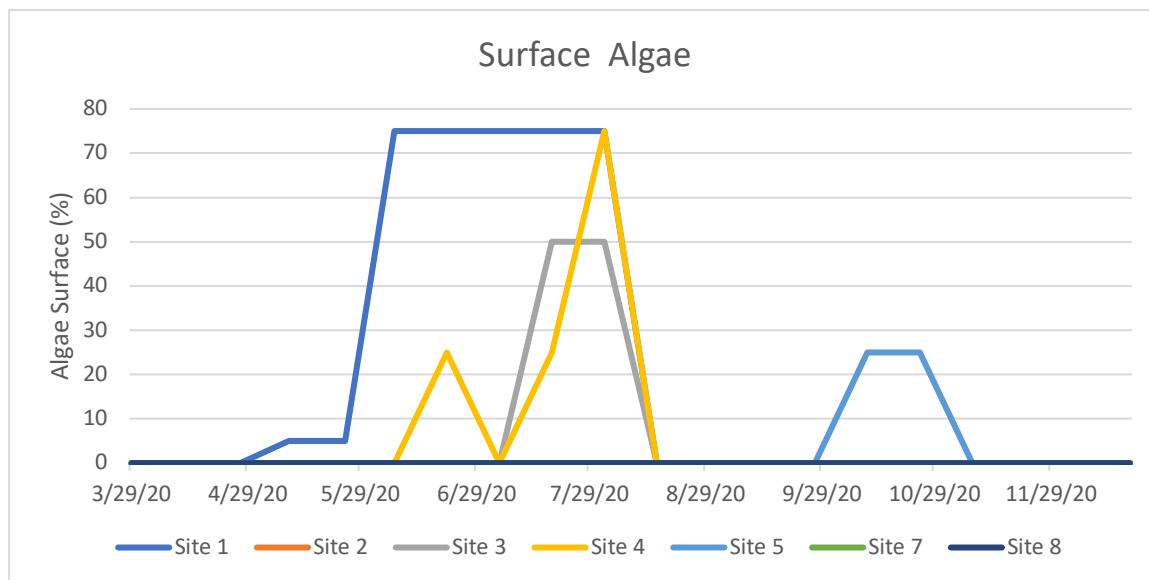
For each survey site, there were minor instream habitat changes throughout the year. Below is a summary of what typically occurred at each site. Surface and subsurface algae percentages for each survey site are also presented.

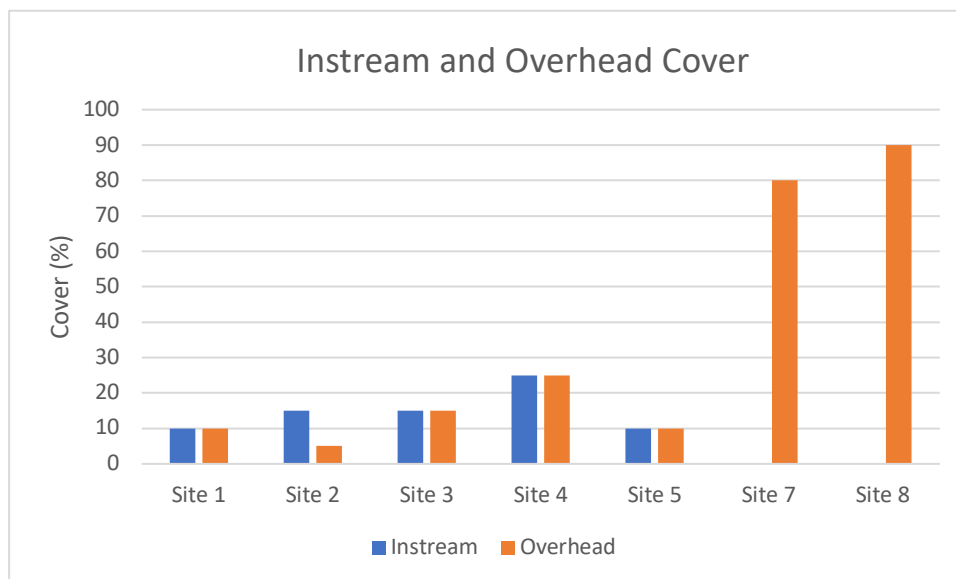
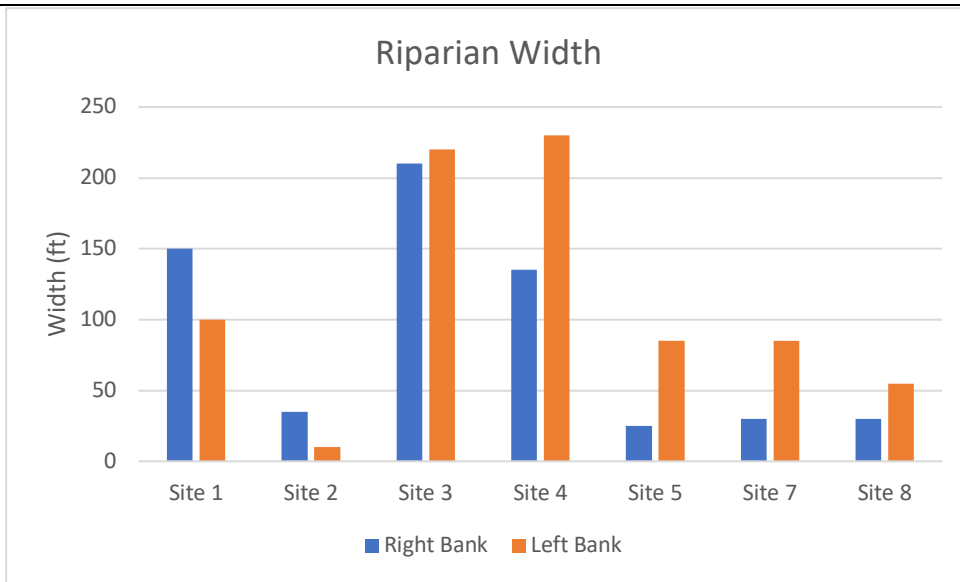
Graphs below present data on instream and overhead cover, riparian width, and riparian moisture. Cover and riparian width did not change during the year. Riparian moisture changed often – sometimes the change was due to weather, but the readings would also vary if measurements were taken within inches of each other; the usefulness of this data is in question. Aerial photos of riparian vegetation were analyzed with no significant changes.
