Utilities Report

Activities During September 2019

Water Department

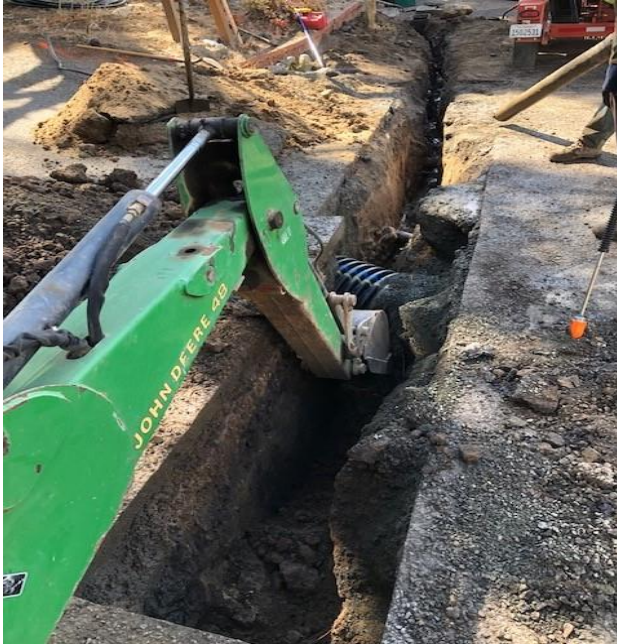
Figure 1 Hillcrest line replacement

On September 26th, a line replacement occurred on the 800 block of Hillcrest. This line had seen many previous repairs and was finally replaced in full. This was a difficult replacement due to proximity to other utility lines and the sanitary sewer.

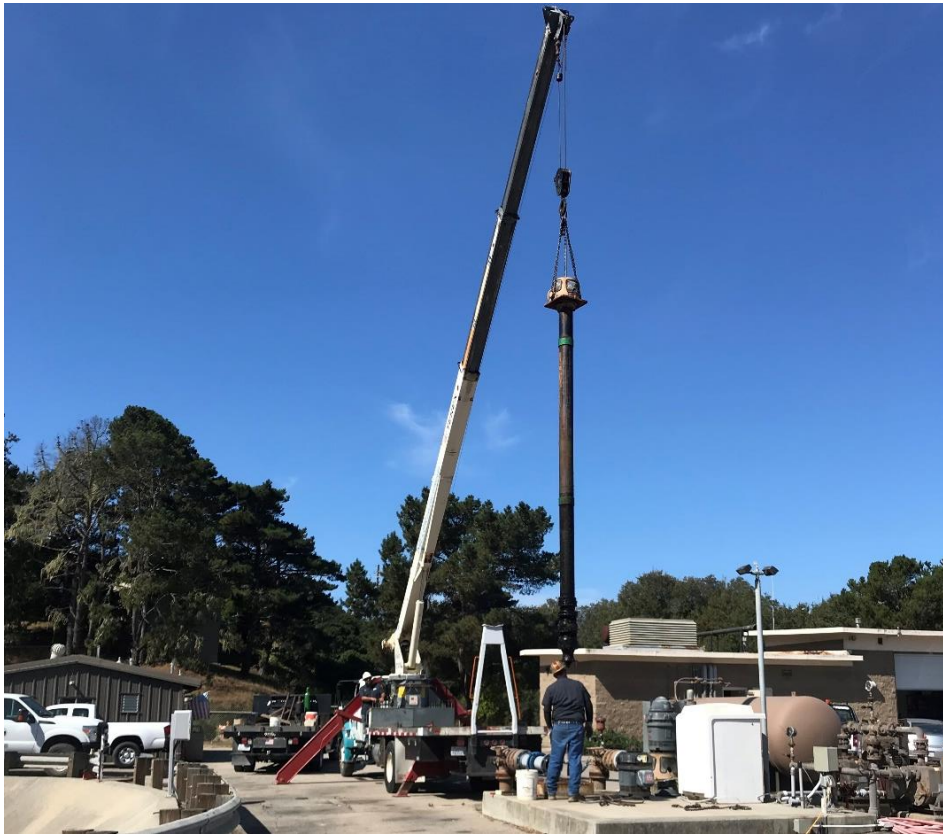
Effluent pump #2 failed. We had Miller Drilling come out, pull the pump, and repair it. It had taken in some debris which caused the seals to move. This made the pump out of balance and spun the retainers out from the base of the bowels.

We hope to have effluent pump #1 pulled in October for a rebuild. Effluent pump #1 puts out about 2/3 of what pump #2 does. This will give us two pumps to handle the rainy season with.

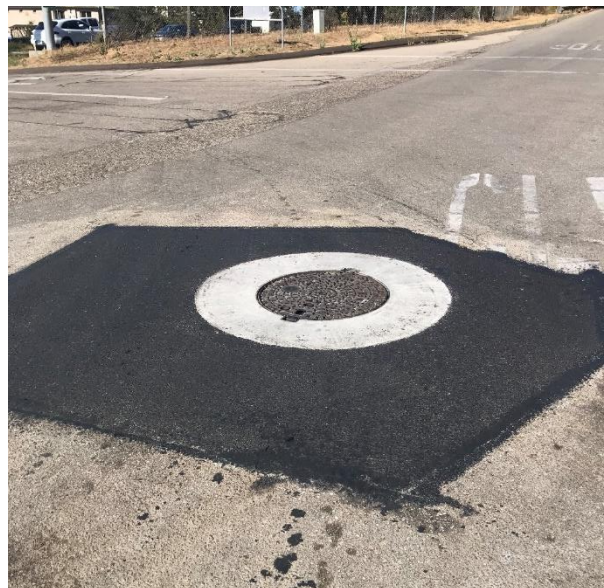
Figure 2 Manhole repair at Main/Windsor

We had Garcia and Sons Construction repair the manhole at the intersection of Main and Windsor. It took us a long time to get this done due to Cal-Trans permitting. We also had difficulty finding a contractor that would travel to Cambria for such a small job.

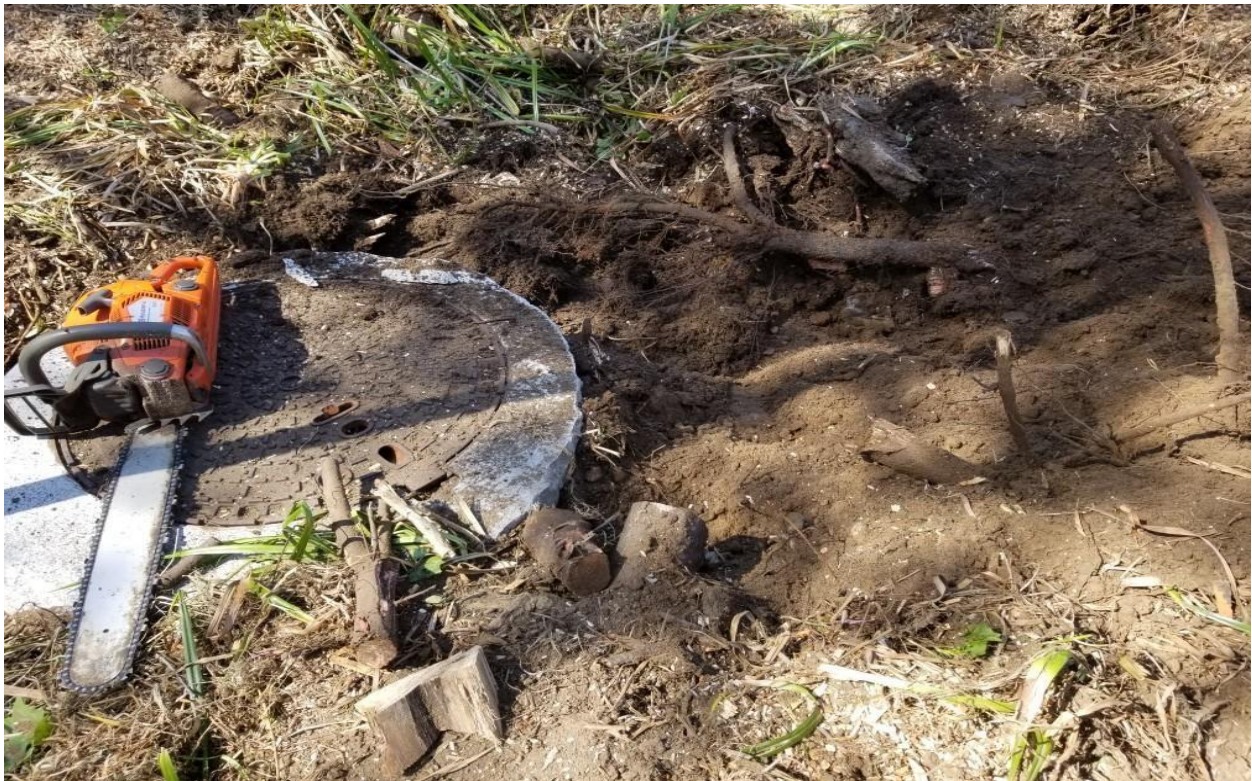
Figure 3 Manhole repair due to root intrusion

Another manhole was repaired due to displacement from tree roots. We had no idea the severity until it was excavated. The repair took much longer than anticipated.

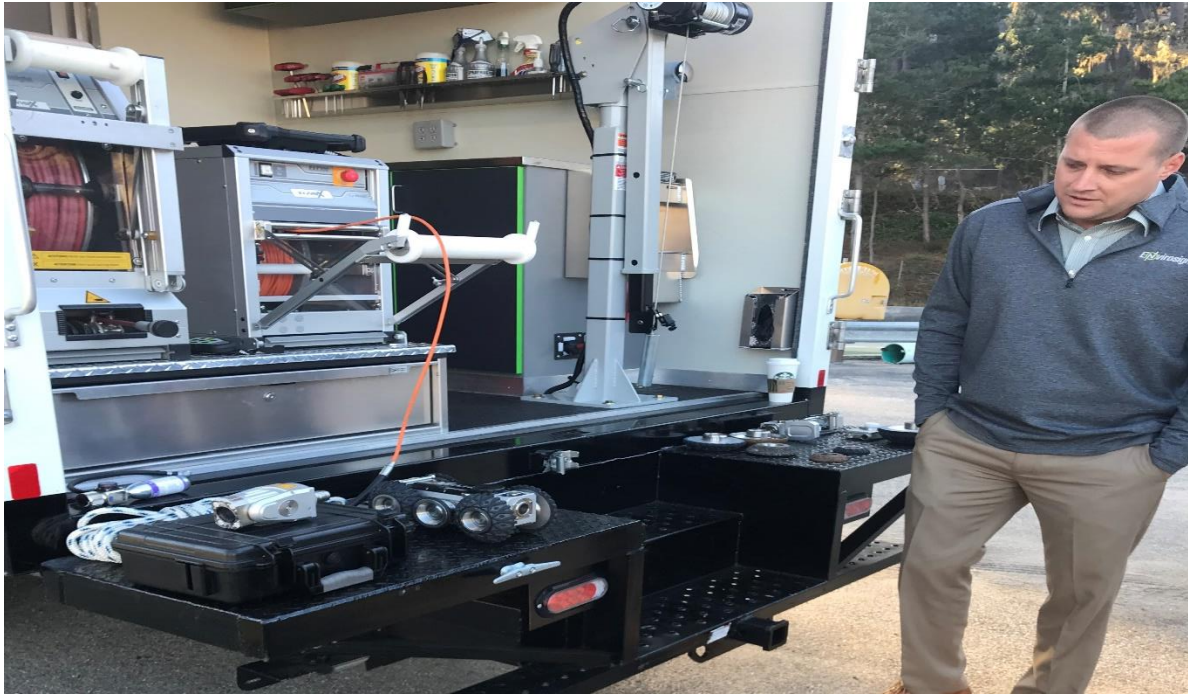
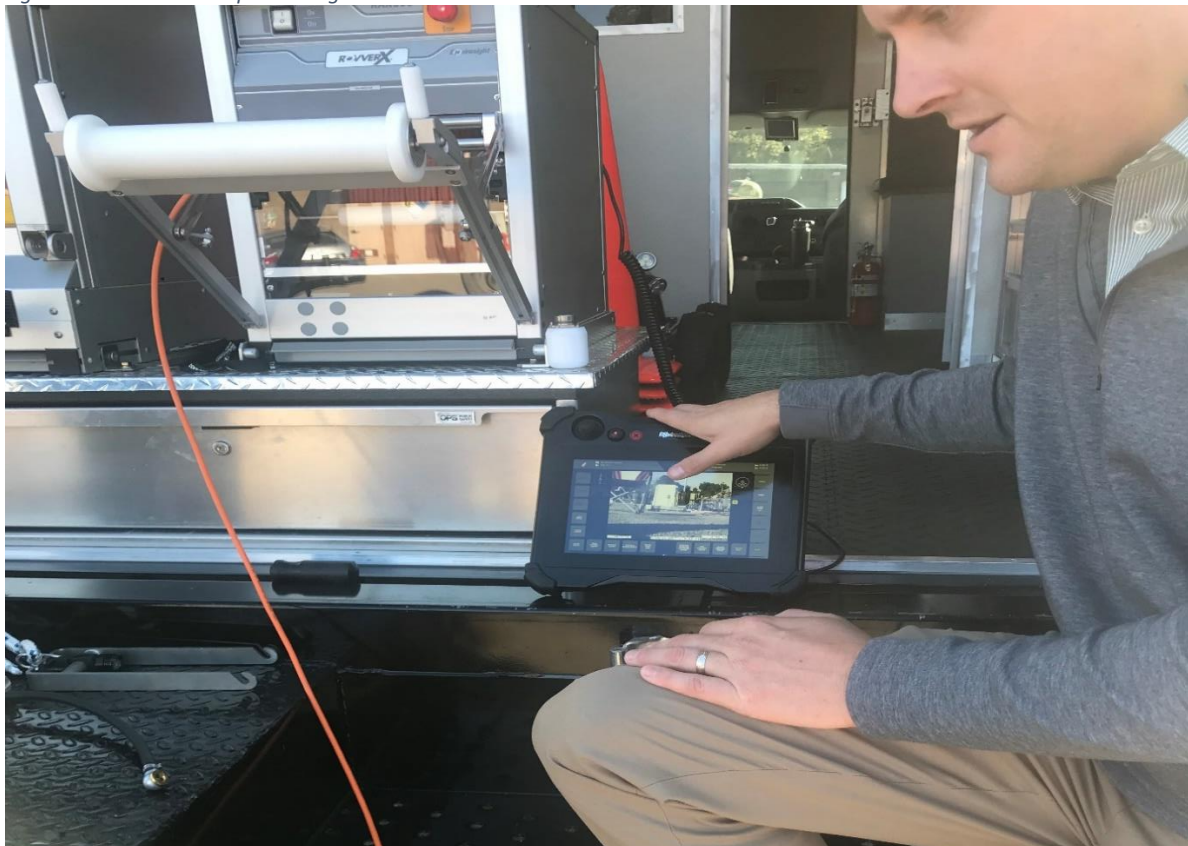
Figures 5 & 6 Haaker rep demoing Rover X camera

Haaker Co. representatives came to the WWTP to demonstrate the Rover X. This is a camera we can use in the collection system to find breaks in the lines or root intrusions. This is also needed to comply with our Sanitary Sewer Management Plan.

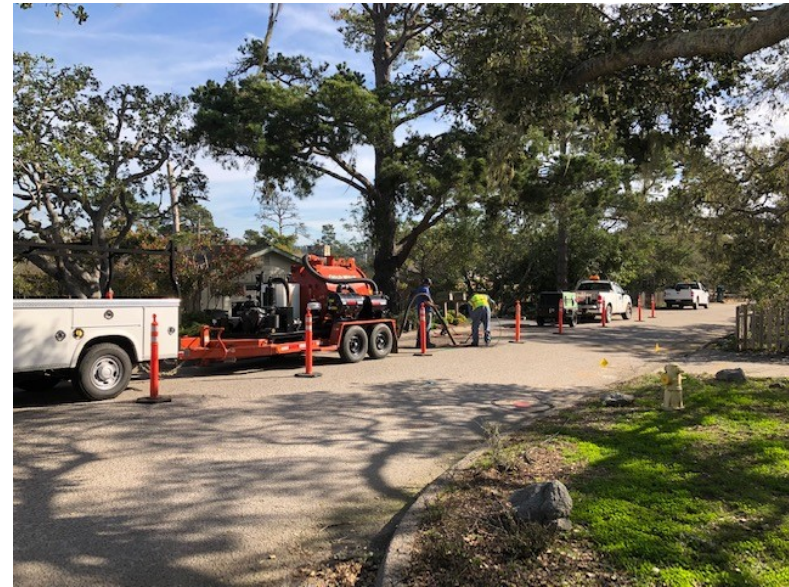
Leak Repair

Initial response depends on multiple factors:

- Flow rate
- Available staffing
- Location
- Service shut-offs

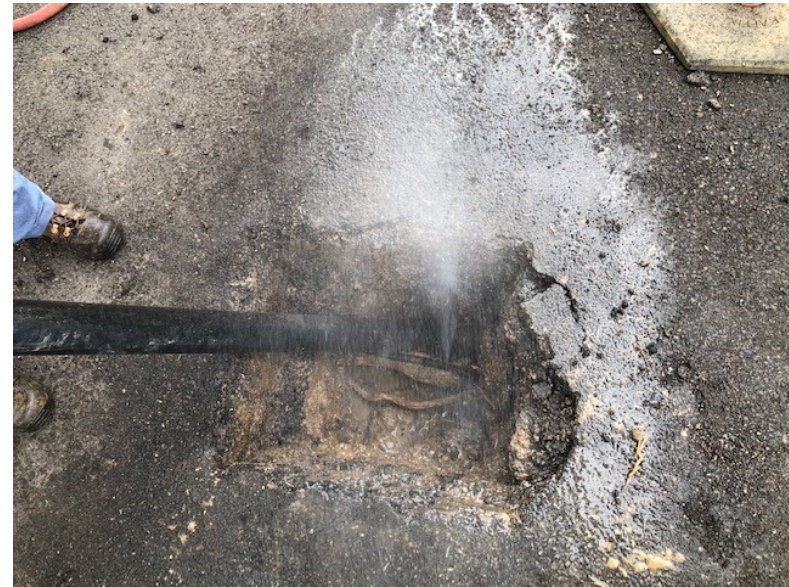
Leak Intensity

Small leaks: 1-5 gpm

- Cost to delay repair is nominal when compared to OT rates

Medium leaks: 10-20 gpm

- Requires immediate response and at least one other operator

Large leaks: >25 gpm

- Requires immediate response and full crew
