**Re: Initial Cambria Emergency Water Supply Project Adaptive Management Plan Monitoring Results (January 2015) / SWCA Project No. 31843**

RE: Final 2015 California Red-legged Frog Field Survey for the Cambria Community Services District Emergency Water Supply Project

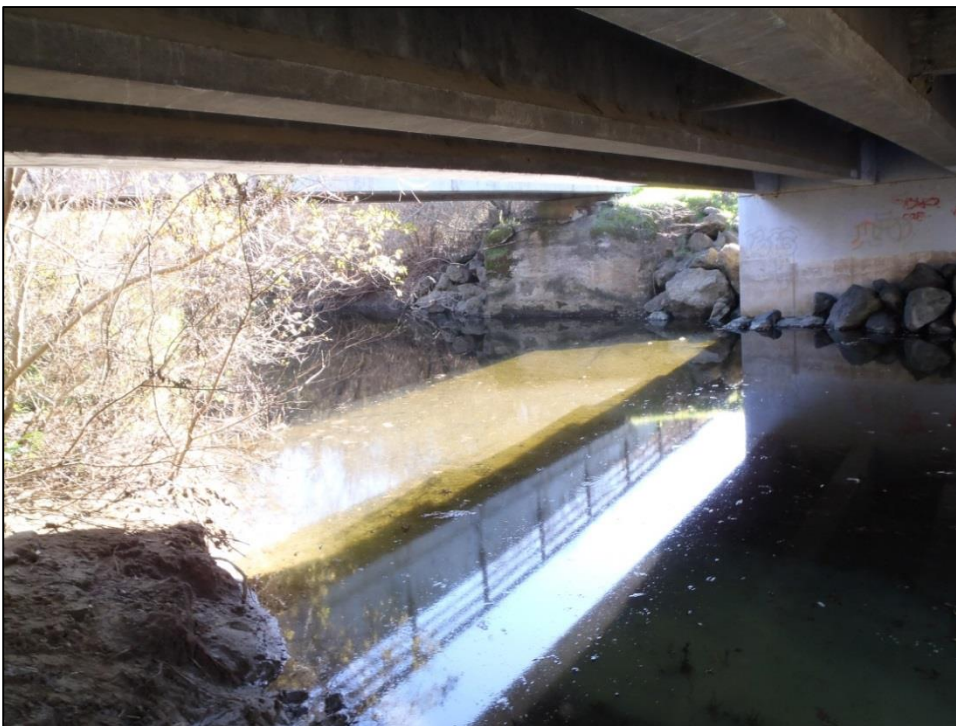
**PHOTO 2:**  
Monitoring Site  
SS2 at pedestrian/  
automobile bridges  
in upper San  
Simeon Creek  
Lagoon.

In order to fully implement the AMP, another stream gage or other measuring device needs to be installed at the upper lagoon site (SS2) to record surface water levels. A request to install a device has been submitted to CCSD. Because the device had not yet been installed, surface levels were not measured at SS2 during the January 12, 2015 data collection. However, SWCA did collect measurements from the base of the existing pedestrian bridge (at the southwest corner of the bridge) on January 30, 2015, with the intention that this measurement can later be extrapolated to a surface water level at SS2. The distance from the bridge to the water surface on January 30 was 136 inches.

Discussions are ongoing with the CCSD to determine where and when a suitable measuring device can be installed at SS2 to monitor lagoon surface water levels. Additionally, a gage will need to be installed in Van Gordon Creek to measure surface water levels when water is present (as noted above, flows have been absent from Van Gordon Creek in the month of January 2015).

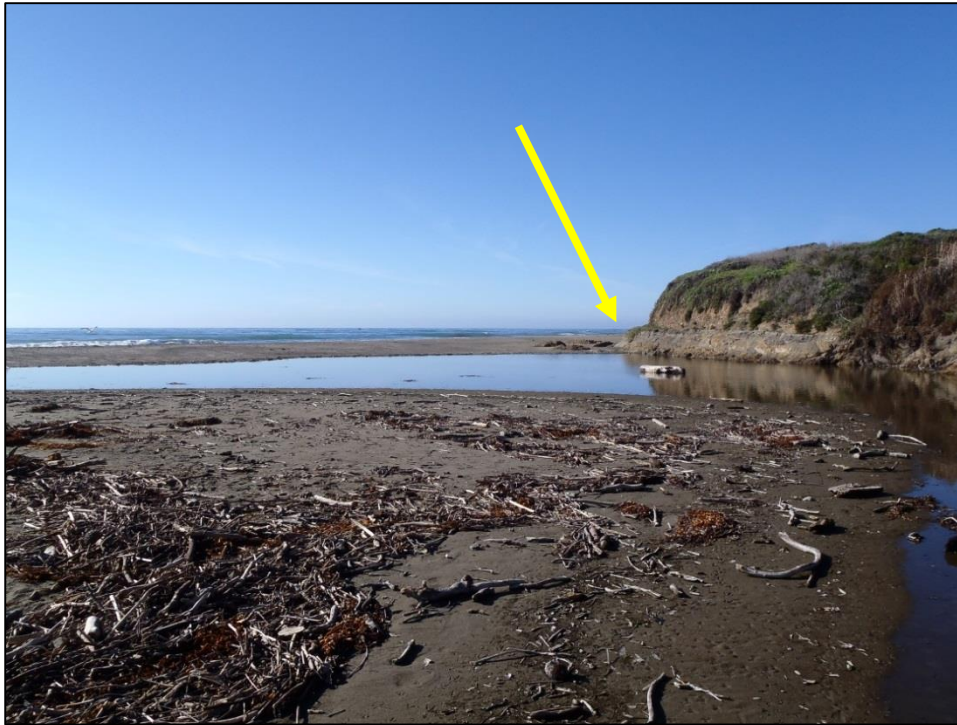
**PHOTO 3:**

Monitoring Site SS3 at lower San Simeon Creek Lagoon (refer to yellow arrow for approximate monitoring site. Sandbar separated creek and ocean during all January monitoring visits.

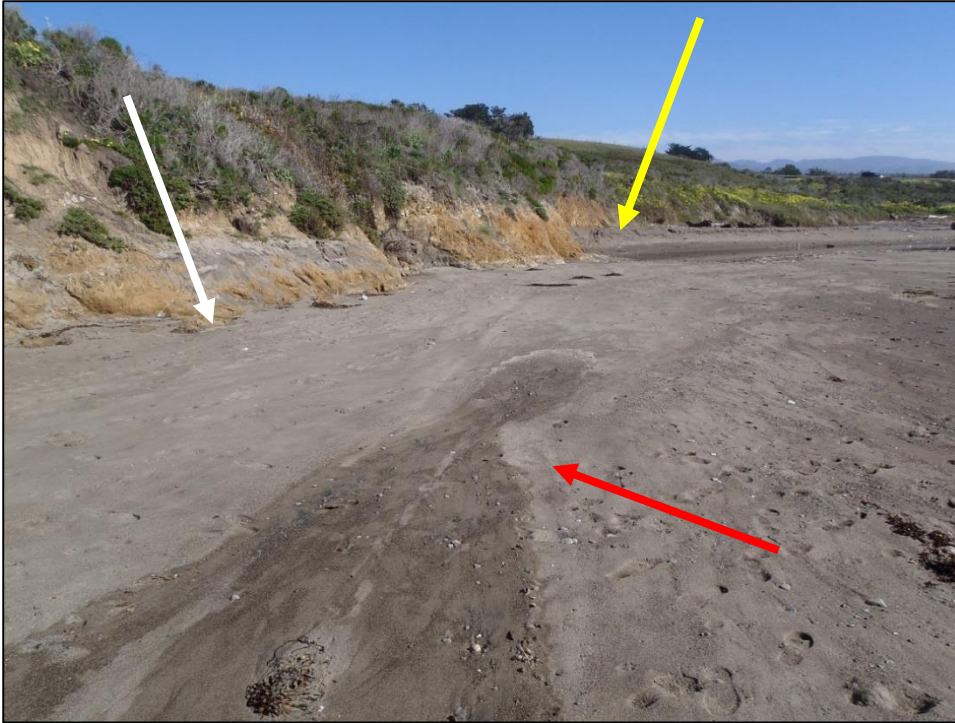
**PHOTO 5:**

View east toward lagoon from sandbar. Note signs of high surf overtopping sandbar (red arrow). Approximate January 12 sampling point is shown by white arrow and January 30 sampling point is shown with yellow arrow.

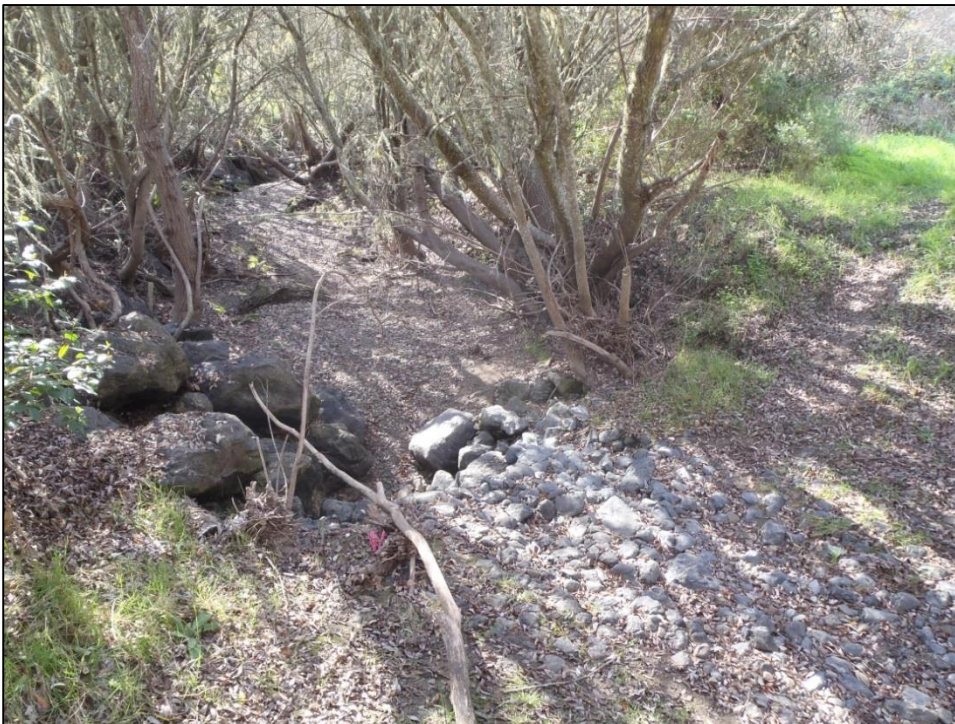
**PHOTO 6:**

Monitoring Site VG1 in Van Gordon Creek. No water was present during the January monitoring visits.

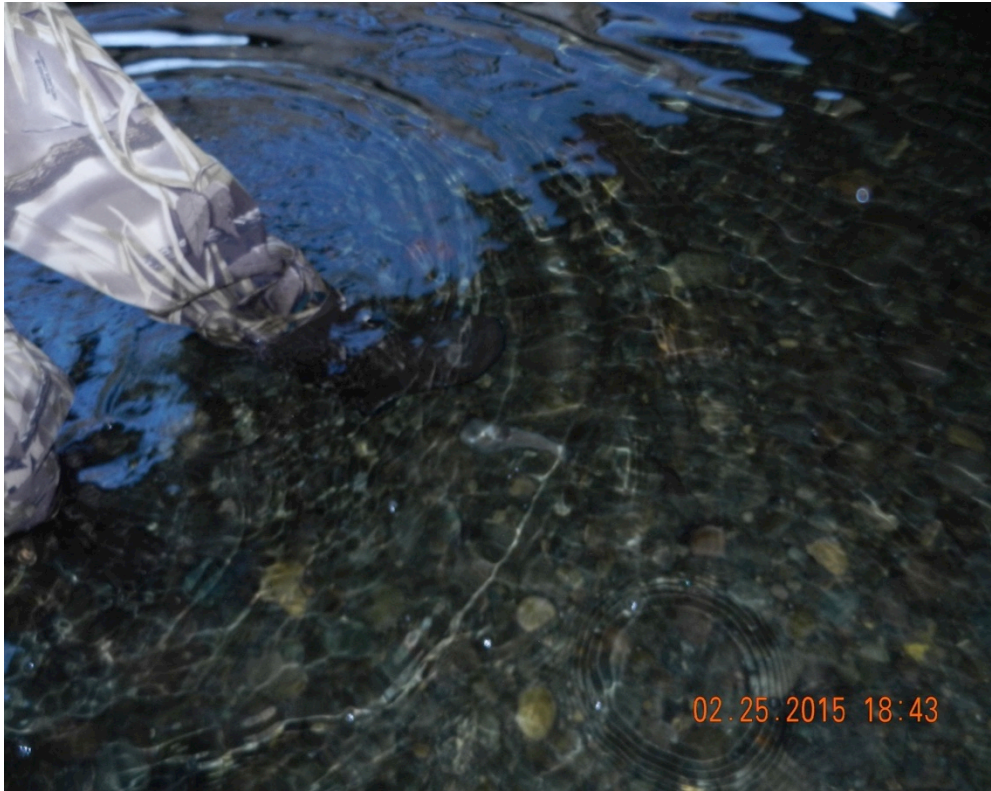
For the February 25, 2015 survey, San Simeon Creek water depth varied from 2 feet to 4 feet. Bankfull width was approximately 32 feet and bankfull depth was approximately 6 feet. There was a 1% slope in the study area. San Simeon instream substrates were approximately 20% silt, 60% gravel, and 20% cobble with some bedrock banks. There was one bedrock pool, approximately 3 feet deep in the study area; the rest of the study area was a glide with frog habitat created by willow rootwads. Water clarity was excellent (see Attachment 2 Photographs). For the April 1, 2015 survey the only change from the February 25, 2015 survey was a slight lowering of the bankfull depth and width and for the August 14 and October 2, 2015 survey the only changes were that the water levels were slightly lower and water clarity was poor due to algae growth (see Attachment 2 Photographs).

Figure 1. Study area water quality on February 25, 2015.

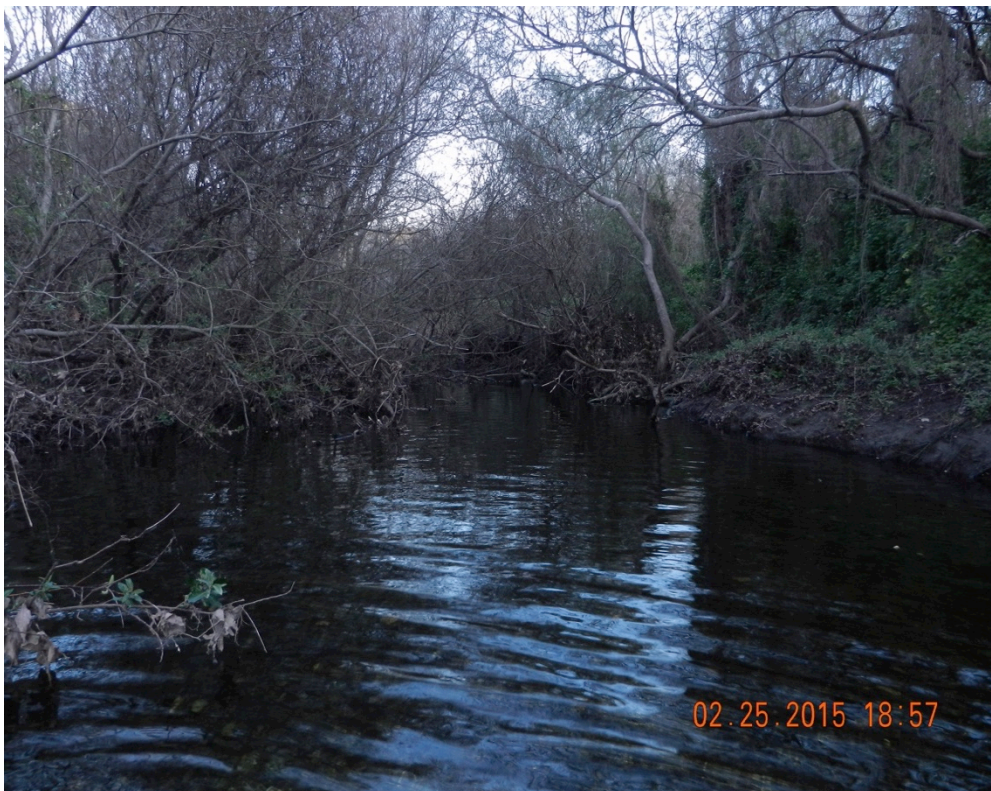
Figure 2. Study area looking east on February 25, 2015.

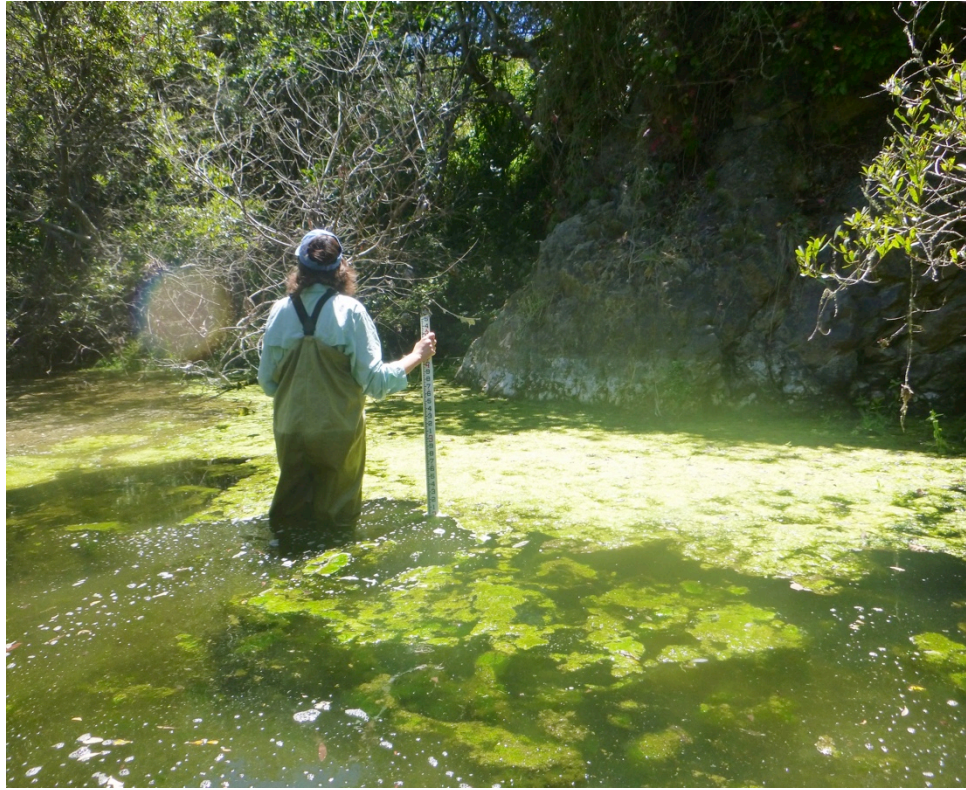
Figure 3. Study area looking east on August 14, 2015.
