Cambria Community Service District Adaptive Management Plan Biological Bi-Monthly Monitoring Report

November 5, 2022

AMP Monitoring Locations

San Simeon and Van Gordon Creeks

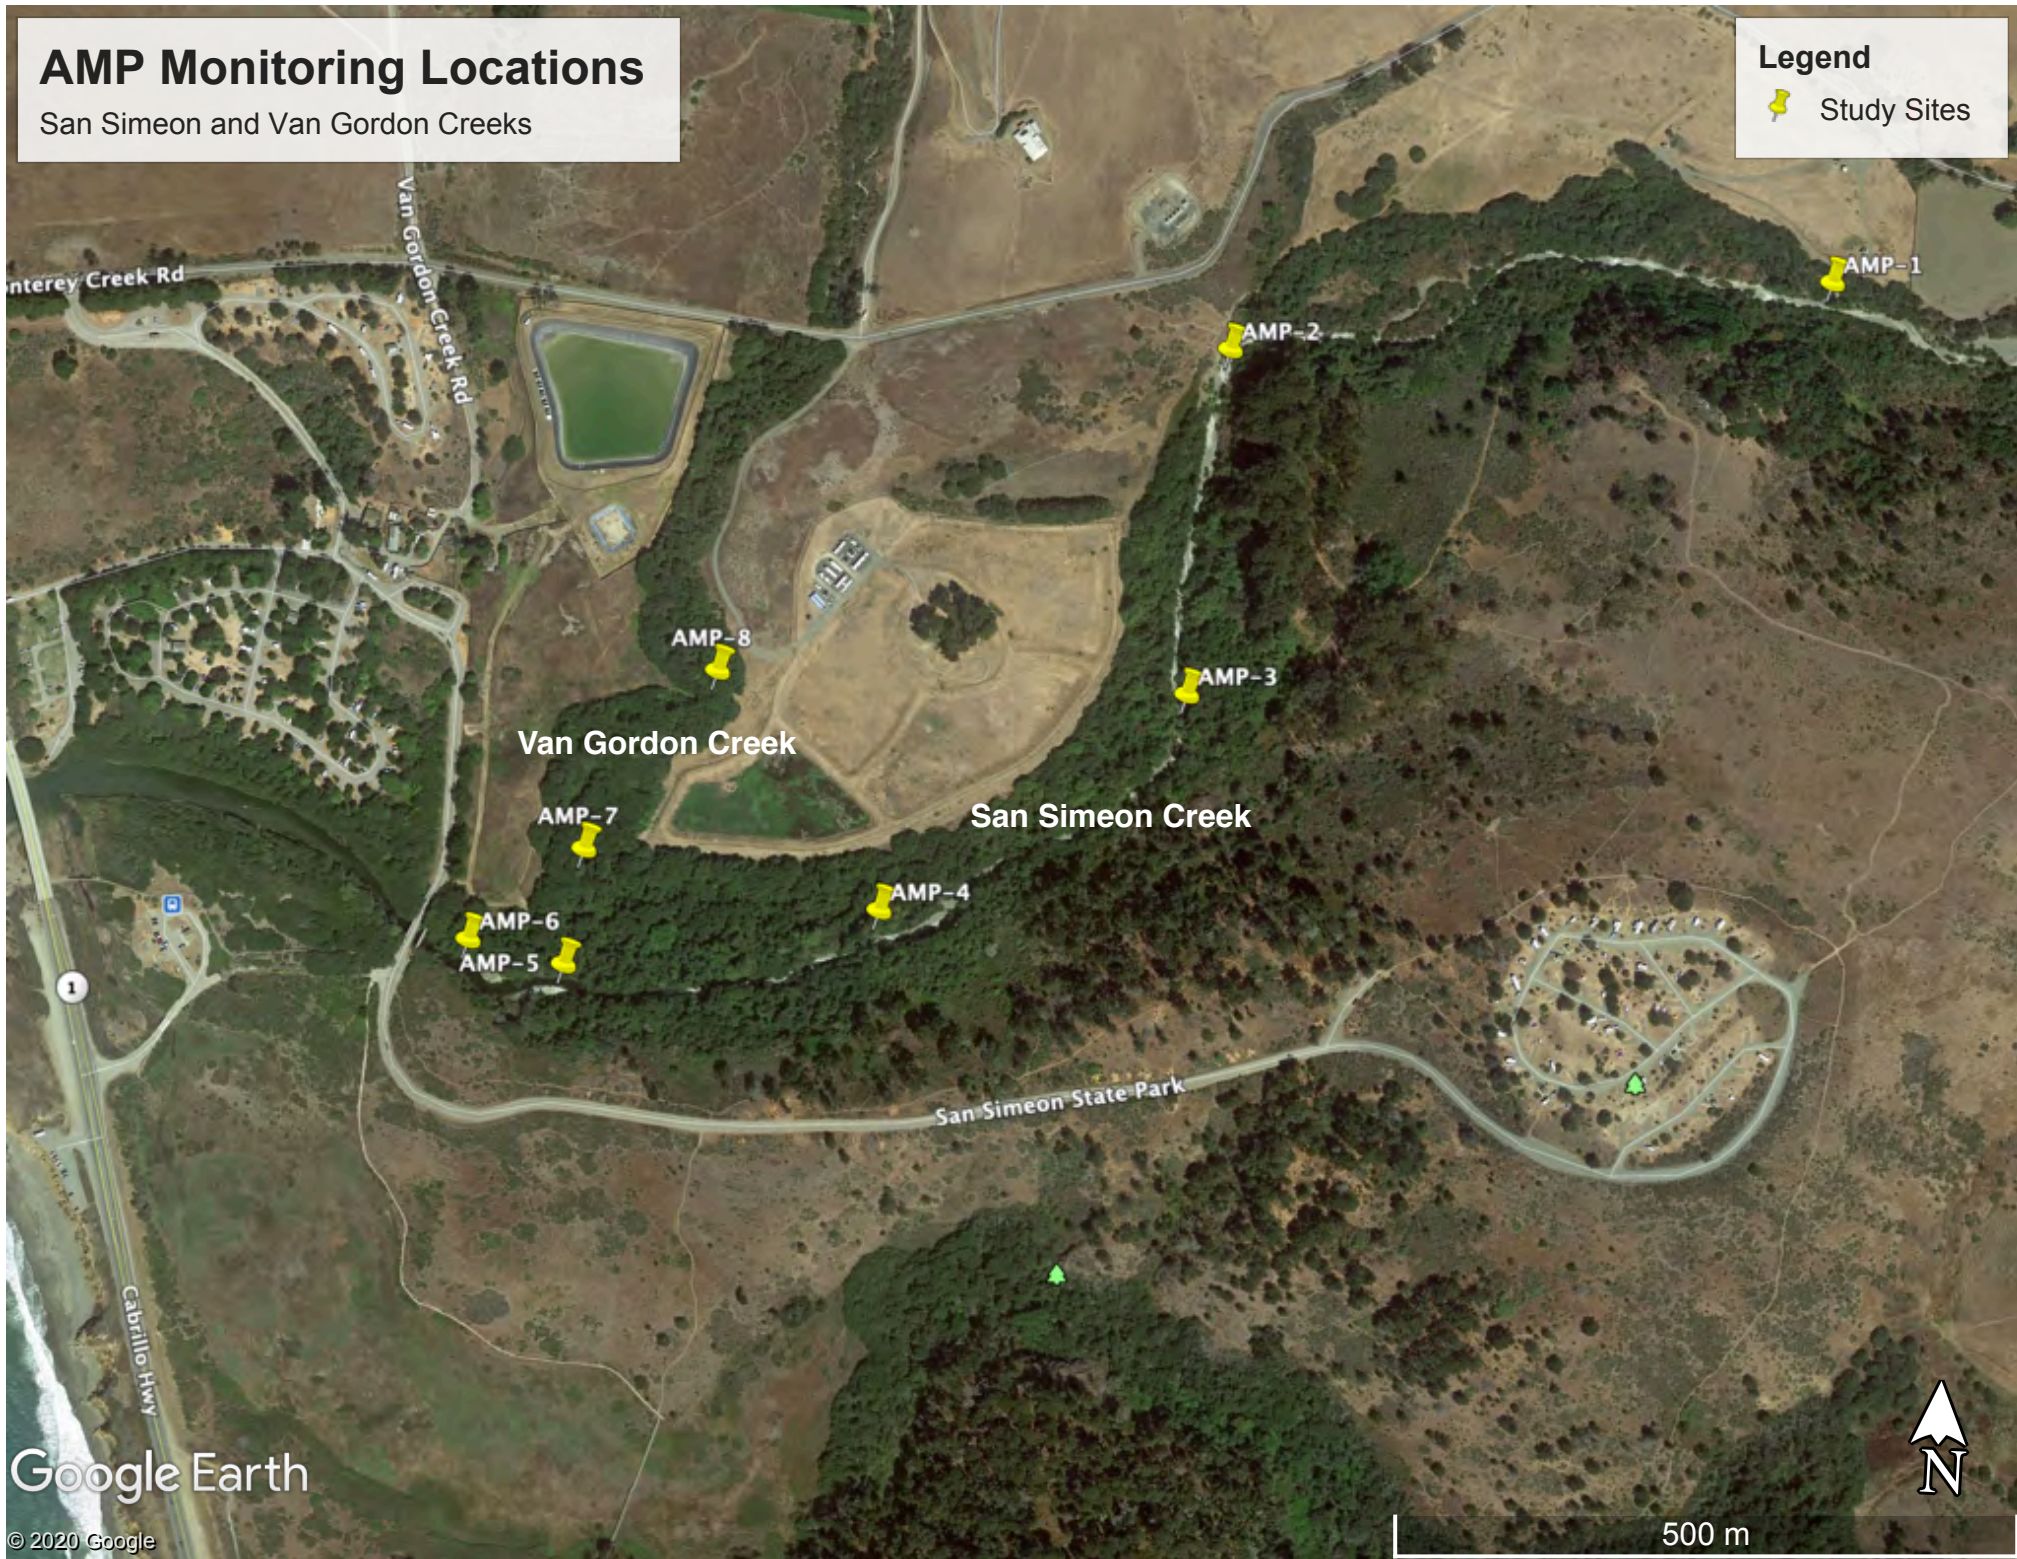
<u>Site 1</u>	<u>Site 2</u>	<u>Site 3</u>	<u>Site 4</u>	<u>Site 5</u>	<u>Site 7*</u>	<u>Site 8</u>
Water Quality							
Temperature (F)	dry	dry	dry	58.9	59	dry	dry
Dissolved Oxygen (%)	dry	dry	dry	23.7	65.5	dry	dry
Dissolved Oxygen (ppm)	dry	dry	dry	2.38	6.58	dry	dry
Total Dissolved Solids (mg/L)	dry	dry	dry	771	885	dry	dry
Salinity (ppt)	dry	dry	dry	0.59	0.69	dry	dry
Water Guage							
Water Level (ft)				na	na		
Site 4 guage is in pool approx.50 m upstream of Site 4 near right bank. Site 5 guage is at site on left bank.							
Species Observed	Stickleback @ Sites 4 & 5 and in isolated pools above Site 4. TWG @ Site 5. Prickly sculpin @ Site 4. One CRLF above Site 4 near powerlines. 2 Snowy egrets, 1 Great blue heron, Quail.						
Comments	Continuous flow ends three-quarters of the way between Sites 4 and 3.						
Location Descriptions	Trail by SS-1	Downstream of rock pool	Draw a line from 9P7 along road to the creek	Stream flow starts/ends	Upstream of Van Gordon confluence	Van Gordon accessed at MW-4	Van Gordon accessed from AWTP

GPS	35°36'0.23"N	35°35'57.55"N	35°35'48.09"N	35°35'41.88"N	35°35'40.00"N	35°35'43.10"N	35°35'48.06"N
	121° 6'33.42"W	121° 6'53.39"W	121° 6'54.29"W	121° 7'4.04"W	121° 7'14.25"W	121° 7'13.85"W	121° 7'9.81"W
	*Site 6 is on State Parks property and is not accessible at this time.						
9P7 Soil Moisture †							
North (%)	7.7						
East (%)	7.9						
South (%)	5.4						
West (%)	7.6						
†Moisture measured on each side of well casing. Max reading is 50%.
